INDOOR AIR QUALITY ASSESSMENT

**Solmonese Elementary School
315 West Main Street
Norton, MA 02766**

Prepared by:
Massachusetts Department of Public Health
Center for Environmental Health
Emergency Response/Indoor Air Quality Program
July 2005

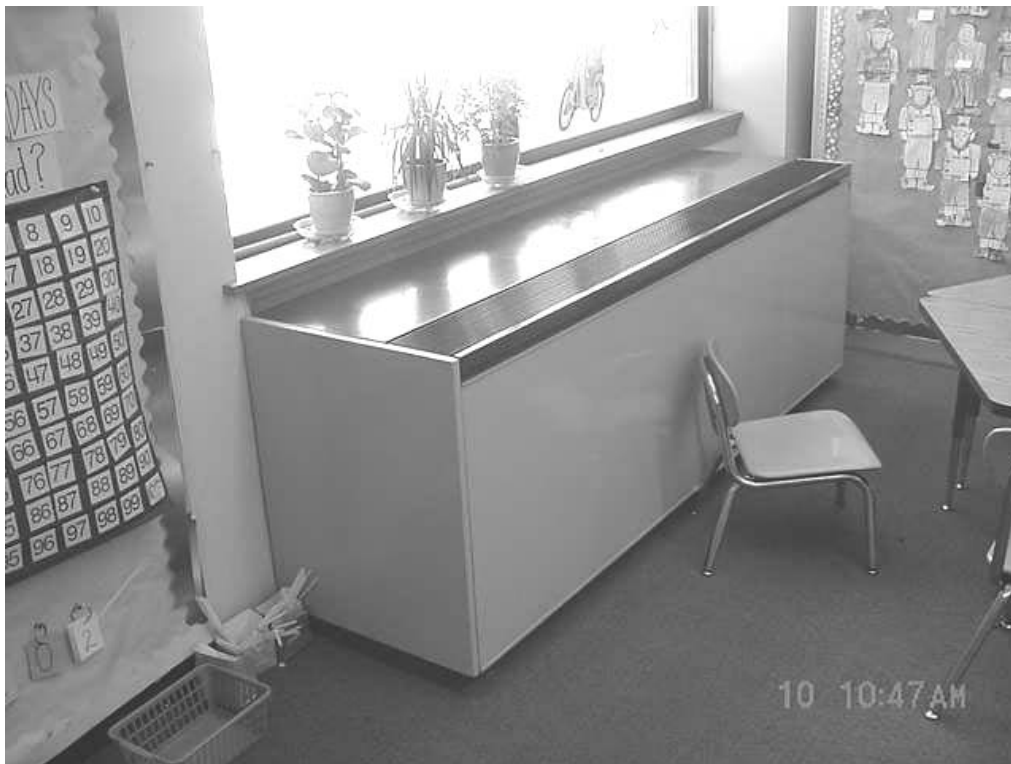
Picture 1

Fresh air in exterior classrooms is supplied by unit ventilator (univent) systems (Picture 1). A univent draws air from outdoors through a fresh air intake located on the exterior wall of the building (Picture 2) and returns air through an air intake located at the

Classroom Univent

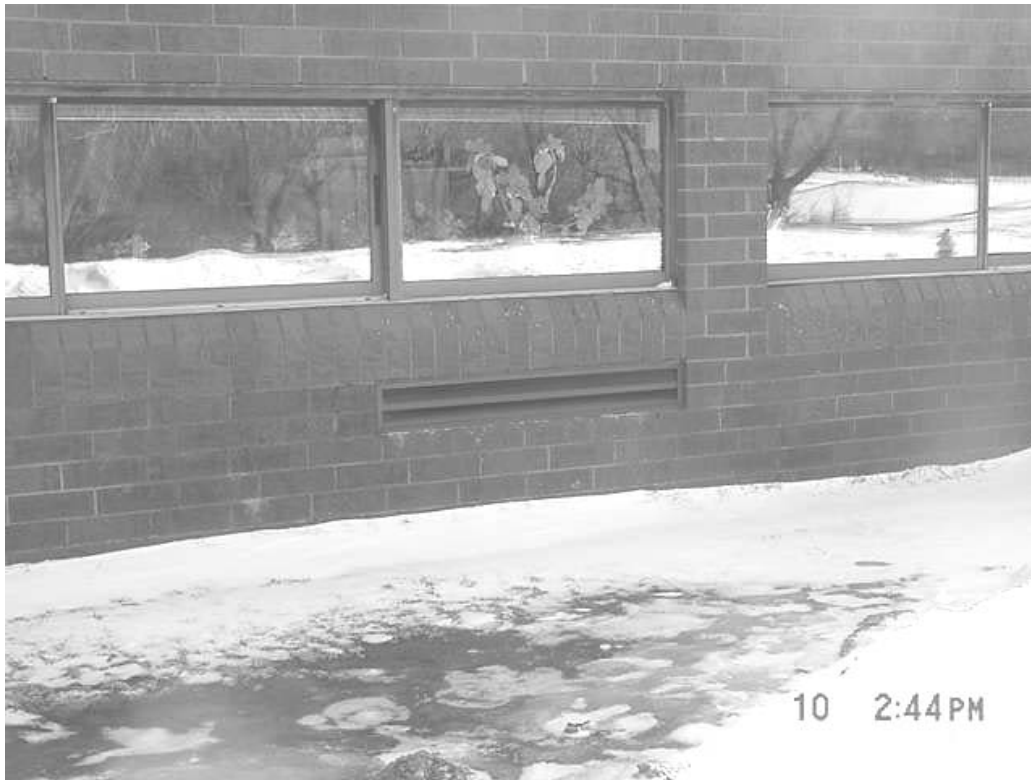
Picture 2

Univent Fresh Air Intake

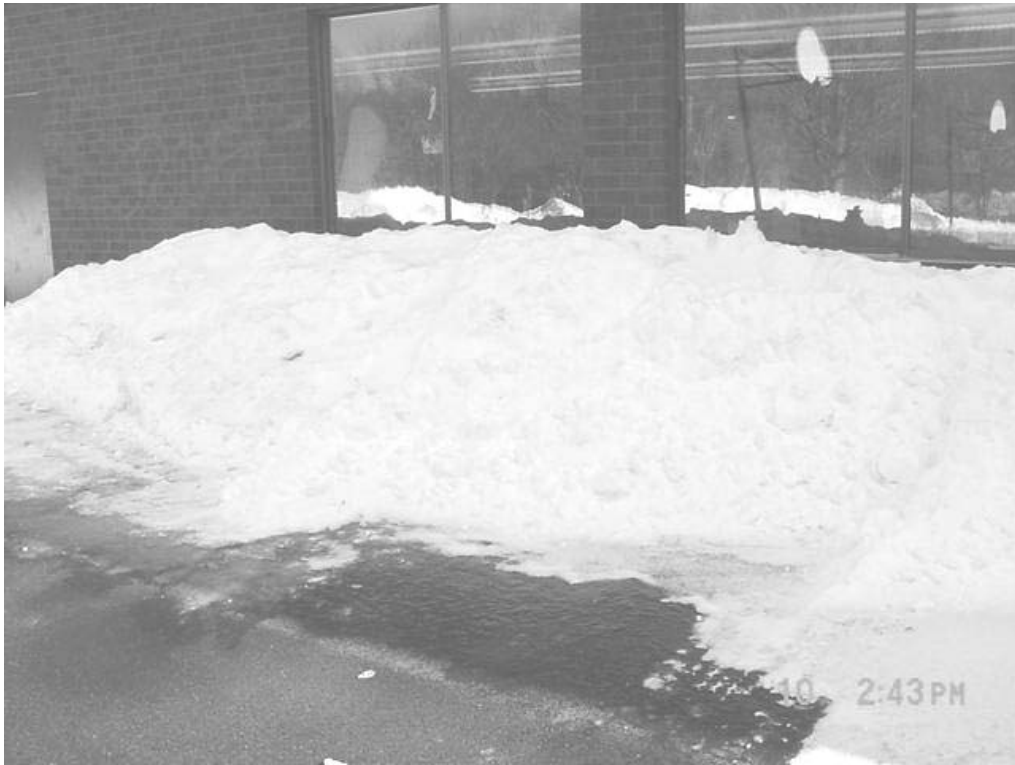
Picture 3

Snow Bank Plowed against Univent Fresh Air Intake

5. Remove all obstructions from supply vents and univents. Close classroom doors to improve air exchange. Work with/educate plowing contractors to prevent the blockage of univent air intakes.

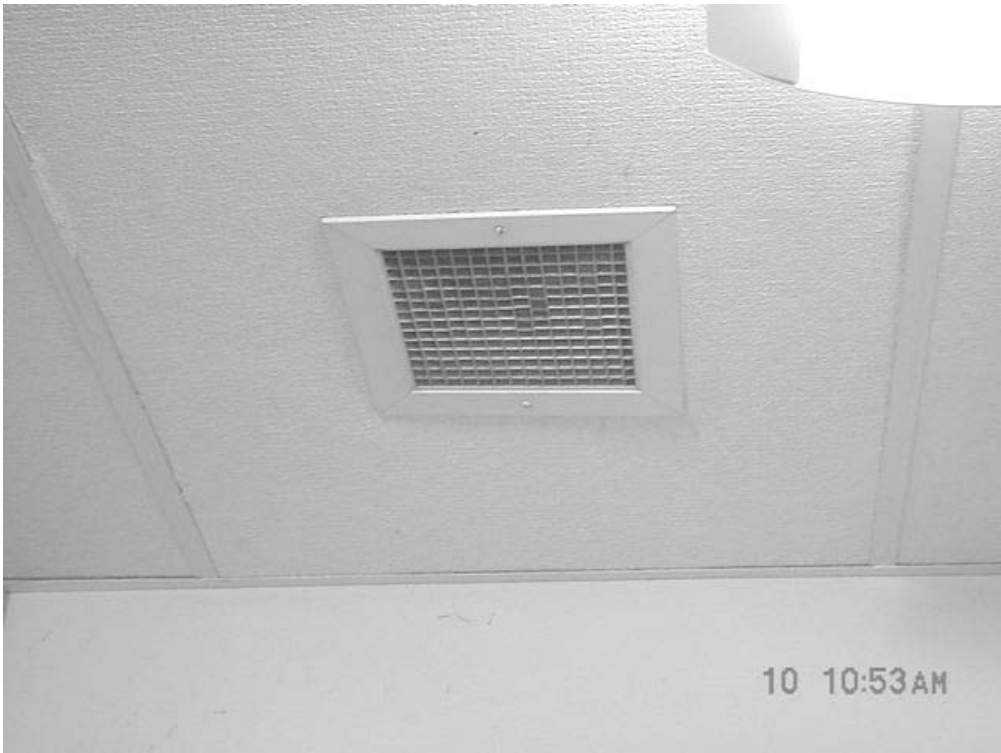
Picture 4

Exhaust ventilation is provided by wall or ceiling-mounted exhaust vents (Picture 4), which are ducted to motorized rooftop fans. These vents were operating in the majority of areas during the assessment. However, in a few areas no draw of air could be detected (Table 1). Without proper exhaust ventilation, environmental pollutants can build up in the indoor environment and lead to indoor air quality complaints. In addition, the location of exhaust vents in some classrooms can limit exhaust efficiency. In several classrooms, exhaust vents are located above hallway doors (Picture 5). When classroom doors are open, exhaust vents will tend to draw air from both the hallway and the classroom reducing the effectiveness of the exhaust vent to remove common environmental pollutants.

Classroom Exhaust Vent

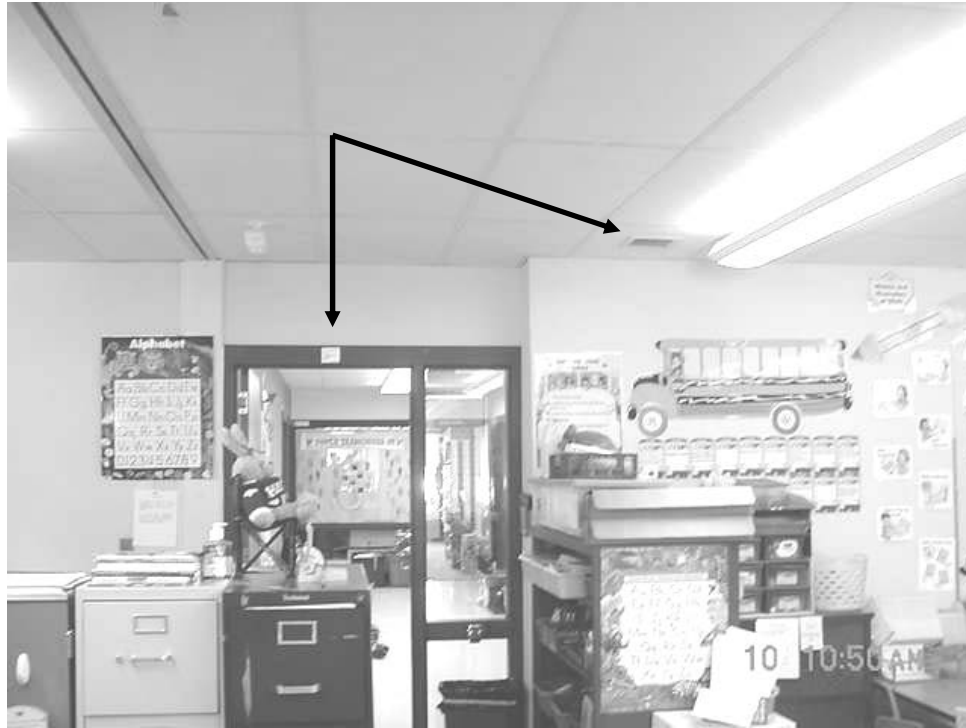
Picture 5

Proximity of Ceiling-Mounted Exhaust Vent to Open Classroom Door

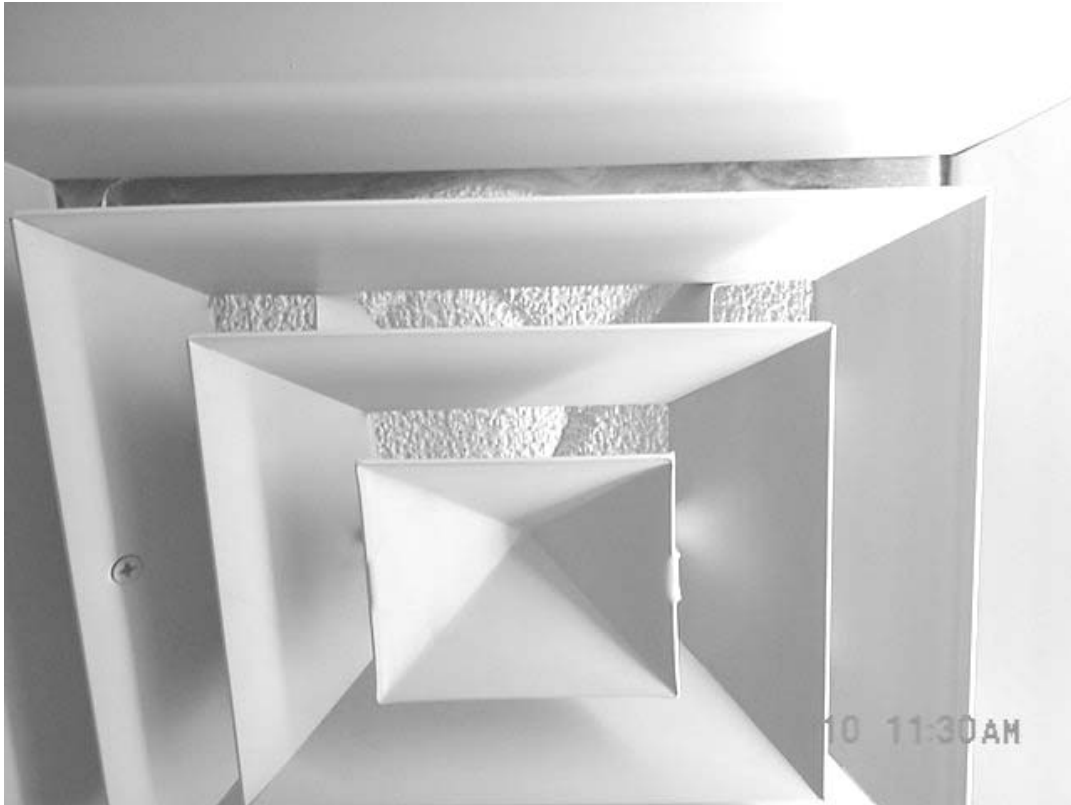
Picture 6

Mechanical ventilation for interior classrooms is provided by rooftop air-handling units (AHUs). Fresh air is distributed via ceiling-mounted air diffusers (Picture 6). Return air is ducted back to AHUs via ceiling-mounted return vents (Picture 7). These systems were operating during the assessment.

Ceiling-Mounted Air Diffuser in Interior Classroom, Note Vent is Stuffed with Fiberglass Insulation

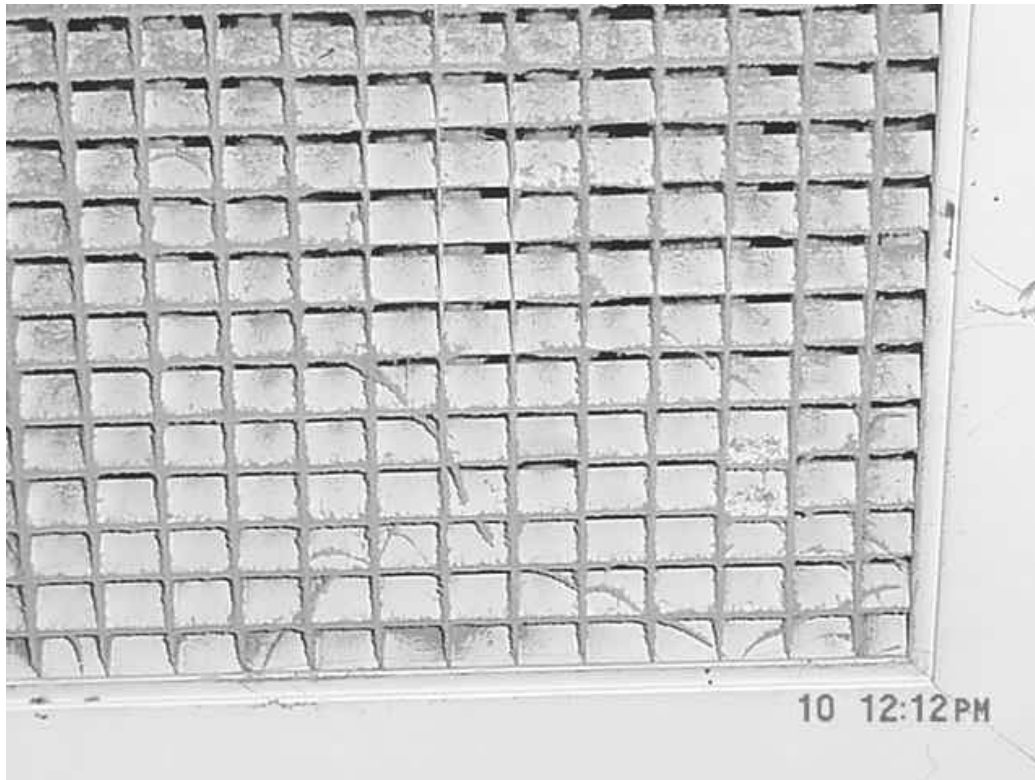
Picture 7

Ceiling-Mounted Return Vent, Note Dust Accumulation

13. Remove debris and dust accumulated on the ventilation grilles.
14. Replace or seal damaged ceiling tiles to prevent exposure to fiberglass.
15. Change filters for air-handling equipment (e.g., univents, AHUs and ACs) as per the manufacturer’s instructions or more frequently if needed. Vacuum interior of units prior to activation to prevent the aerosolization of dirt, dust and particulates. Ensure filters fit flush in their racks with no spaces in between allowing bypass of unfiltered air into the unit.

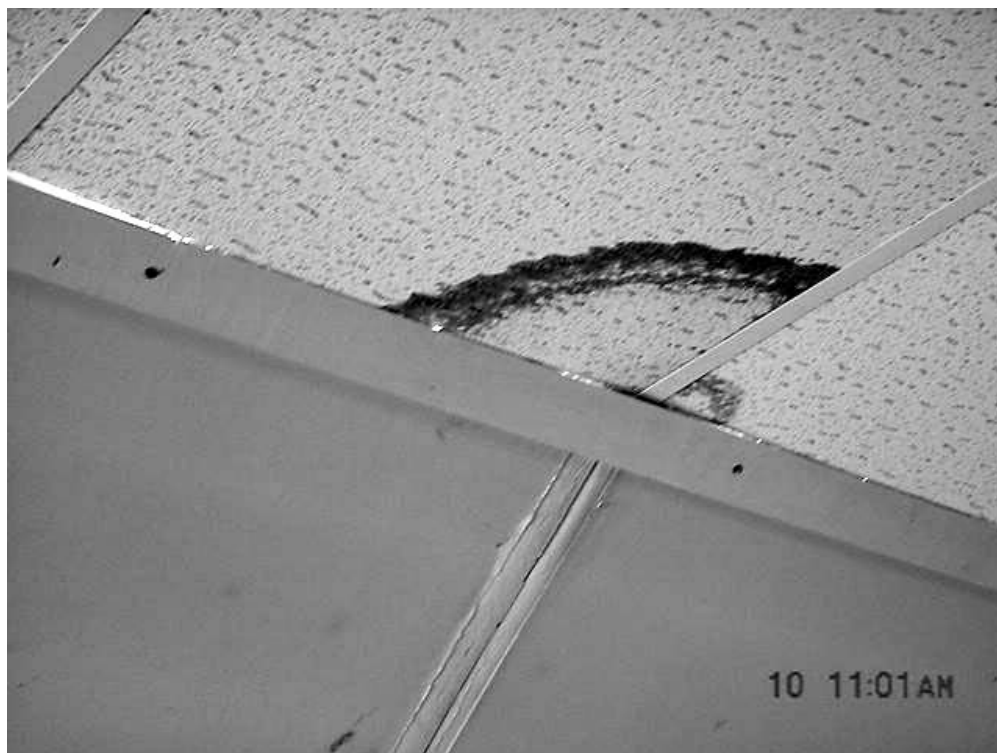
Picture 8

A number of rooms had water-stained ceiling tiles, indicating roof and/or plumbing leaks (Picture 8). Water-damaged ceiling tiles can provide a source of mold growth and should be replaced after a water leak is discovered and repaired. A portion of the building has

Water Damaged Ceiling Tile

8. Identify and repair sources of water leaks. Consider permanently sealing skylights to make watertight. Replace water-damaged ceiling tiles. These ceiling tiles can be a source of microbial growth. Examine the non-porous surface beneath the removed ceiling tiles and disinfect with an appropriate antimicrobial.

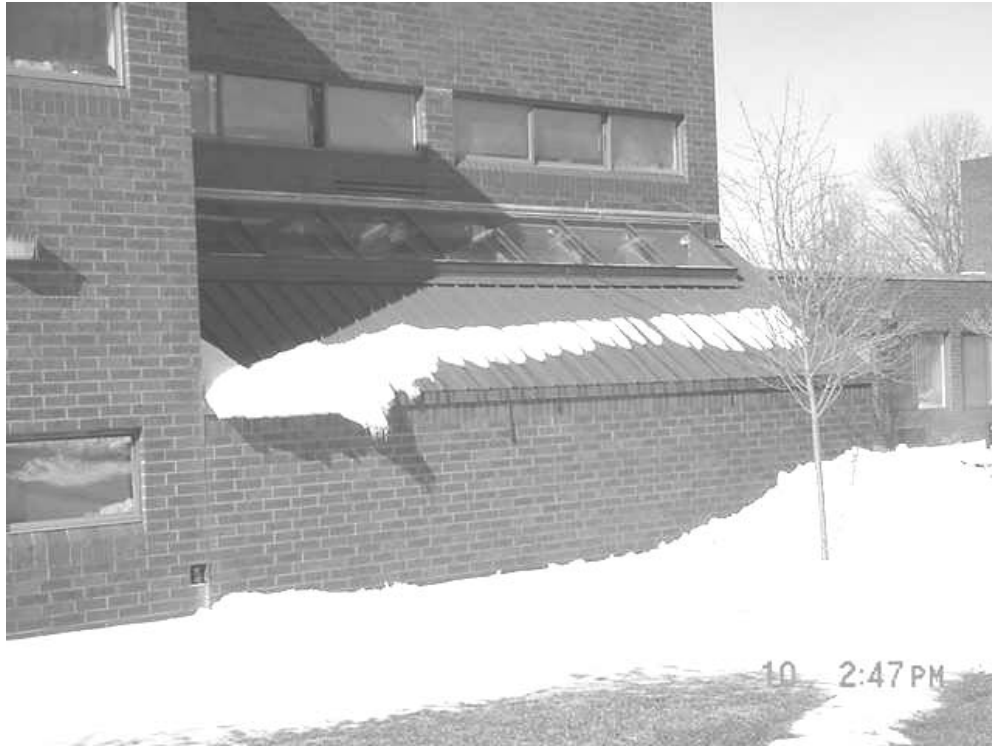
Picture 9

a sloped metal roof and skylights that have a history of leaks (Picture 9). Examination of the skylights found broken panes of glass (Picture 10). Dark staining on the surface of gypsum wallboard (GW) (Picture 11), in areas adjacent to the skylights was observed. This staining may be evidence of mold growth.

Sloped Metal Roof and Skylights

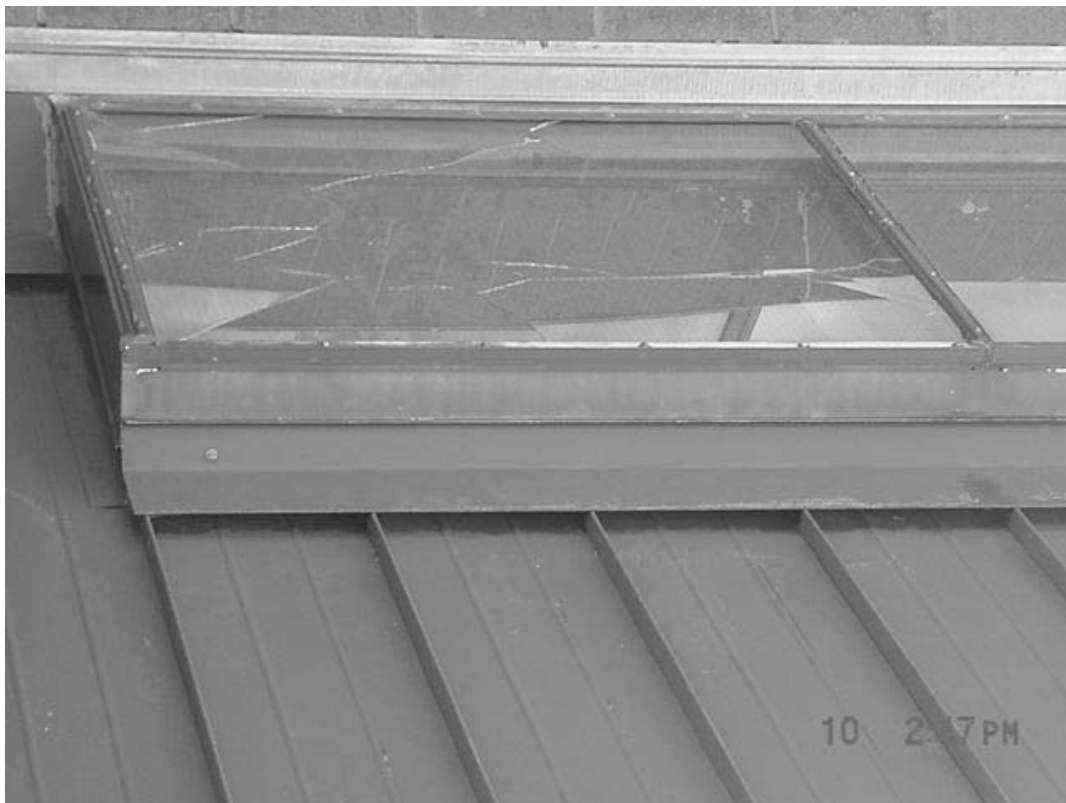
Picture 10

Broken Glass Skylight

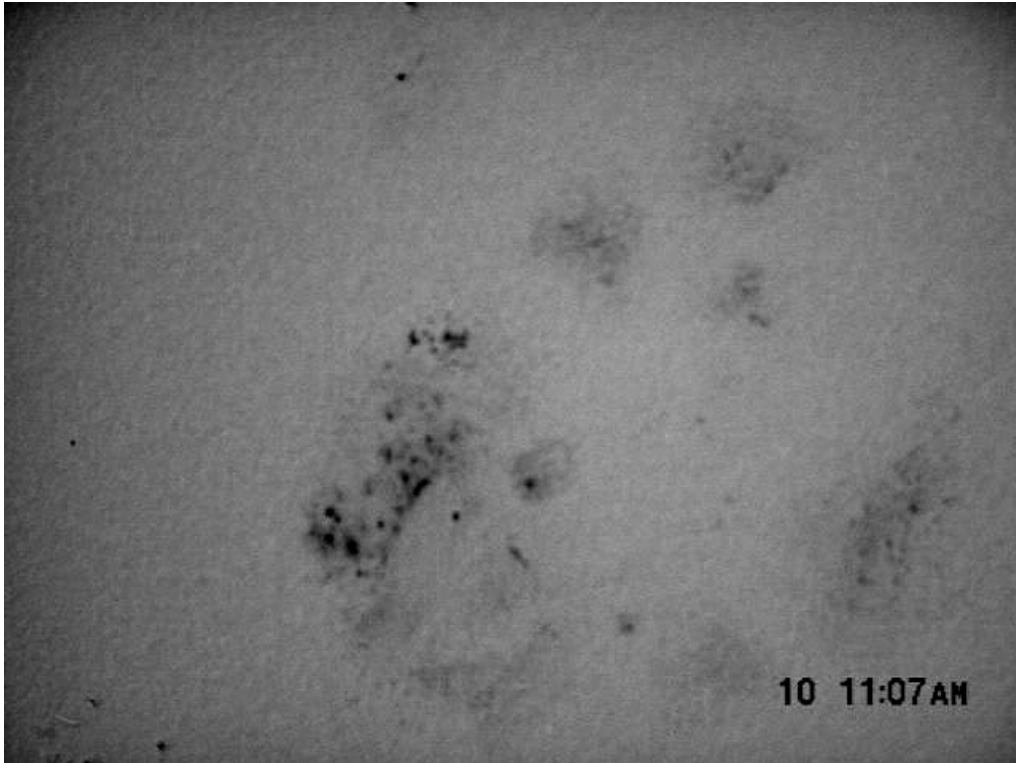
Picture 11

Possible Mold Growth (as Indicated by Dark Stains) on Surface of GW

9. Clean the surface of GW using a high efficiency particulate arrestance (HEPA) filter equipped vacuum cleaner with a brush attachment. If mold growth has *colonized* into the GW, removal or replacement should be considered.

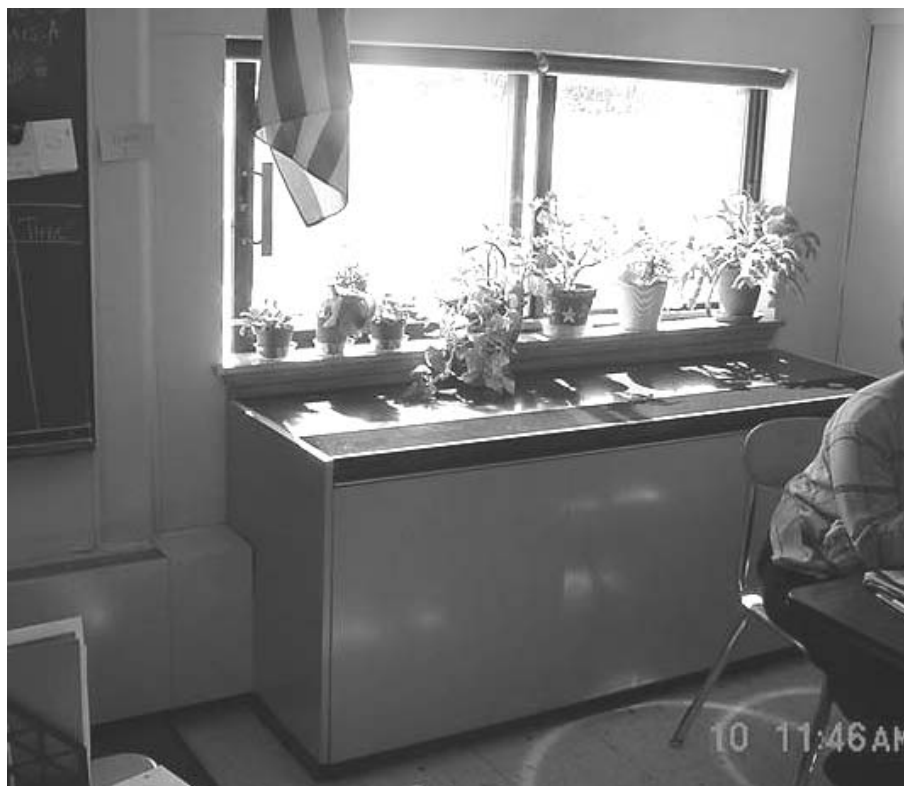
Picture 12

Plants were noted in several classrooms. Some plants were placed near ventilation sources (Picture 12). Plants can be a source of pollen and mold, which can be respiratory irritants for some individuals. Plants should also be located away from univents to prevent the aerosolization of dirt, pollen or mold. Plants should also be properly maintained and equipped with drip pans.

Flowering Plants near Univent Air Diffuser

12. Examine plants in classrooms for mold growth in water catch basins. Disinfect water catch basins if necessary. Remove plants from ventilation sources.

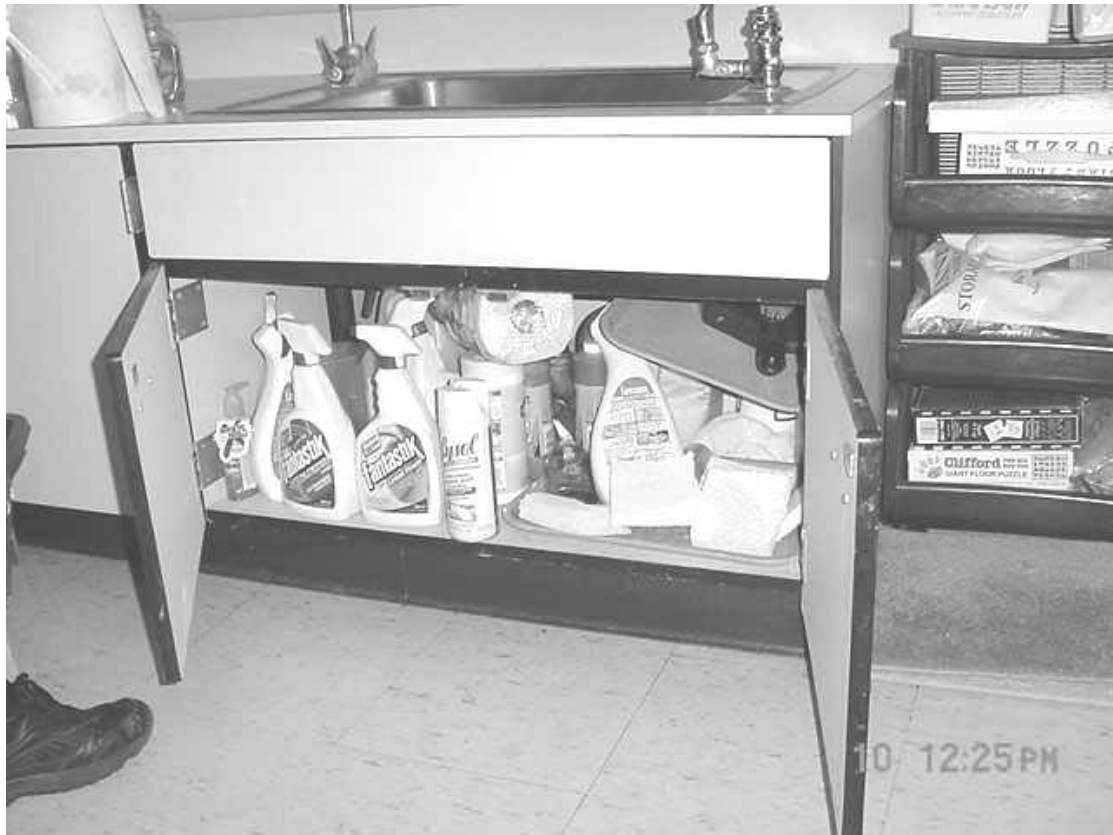
Picture 14

Cleaning products, aerosol cans and unlabeled spray bottles were found on countertops and/or beneath sinks in a number of classrooms (Picture 14). These materials may contain VOCs and other chemicals, which can be irritating to the eyes, nose and throat and should be stored properly and kept out of reach of students. Spray bottles should also be properly labeled in the event of an emergency.

Cleaning Products, Spray Bottles and Aerosol Cans beneath Classroom Sink

16. Store cleaning products properly and out of reach of students. Ensure spray bottles are properly labeled in case of emergency.
17. Consider discontinuing the use of tennis balls on furniture and replacing tennis balls with alternative “glides”. Refer to Picture 18 for an example.

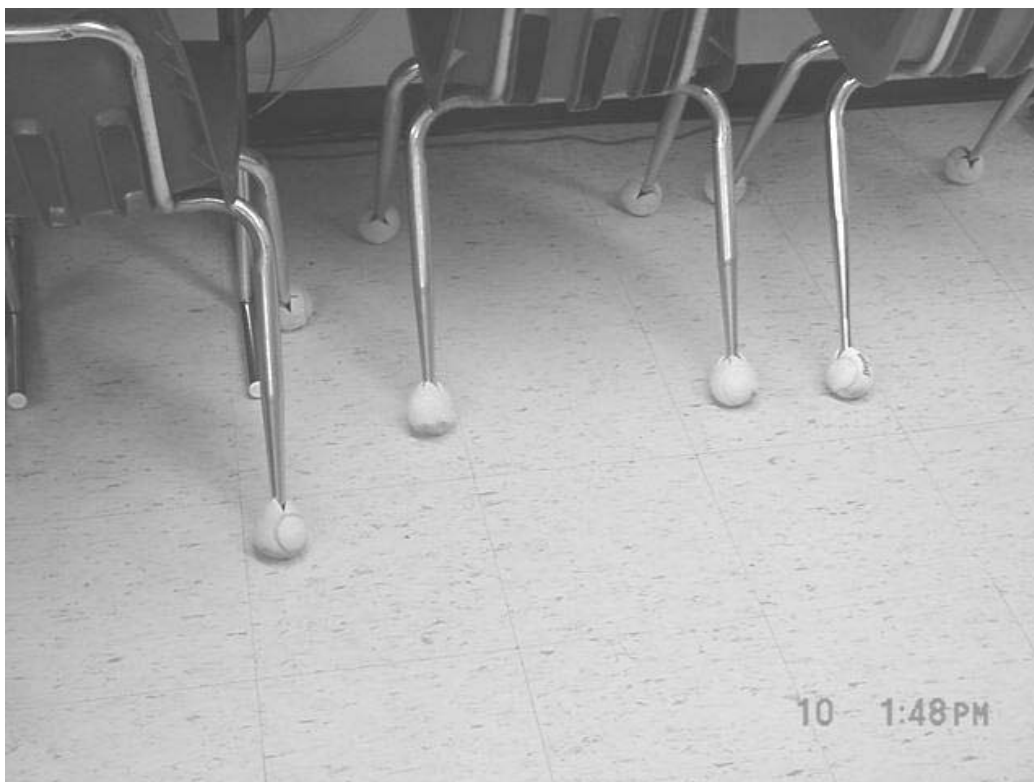
Picture 15

In an effort to reduce noise from sliding chairs, tennis balls had been sliced open and placed on chair legs (Picture 16). Tennis balls are made of a number of materials that are a source of respiratory irritants. Constant wearing of tennis balls can produce fibers and off-gas VOCs. Tennis balls are made with a natural rubber latex bladder, which becomes abraded when used as a chair leg pad. Use of tennis balls in this manner may introduce latex dust into the school environment. Some individuals are highly allergic to latex (e.g., spina bifida patients) (SBAA, 2001). It is recommended that the use of materials containing latex be limited in buildings to reduce the likelihood of symptoms in sensitive individuals (NIOSH, 1997). A question and answer sheet concerning latex allergy is attached as [Appendix C](#) (NIOSH, 1998).

Tennis Balls on Chair Legs

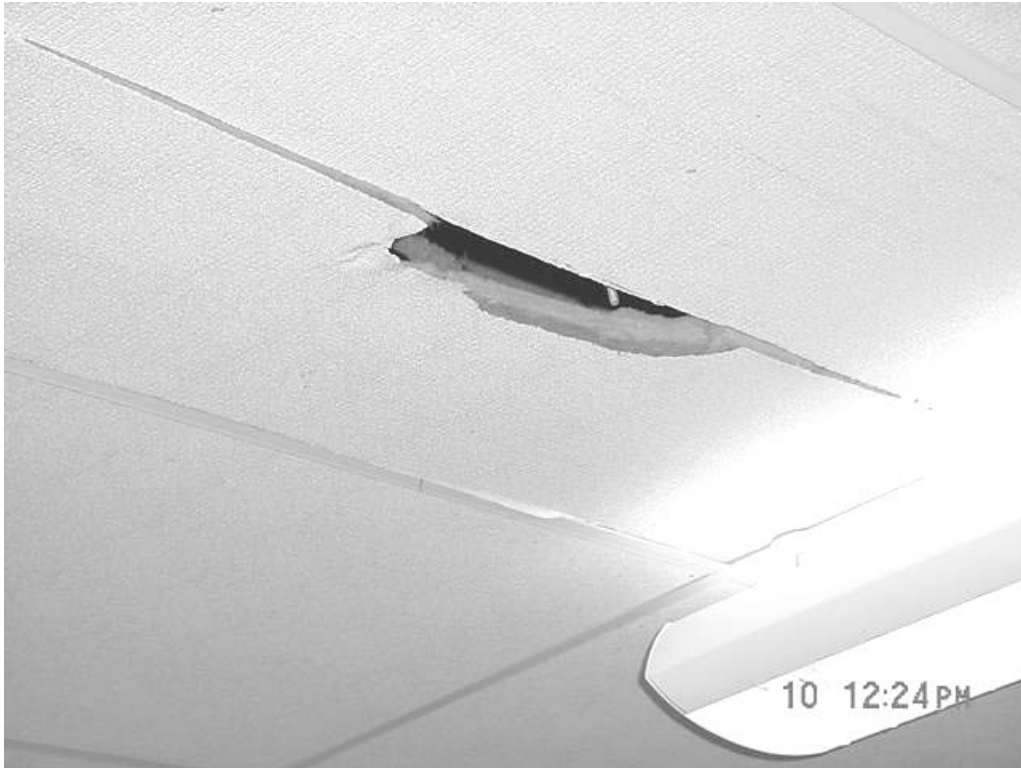
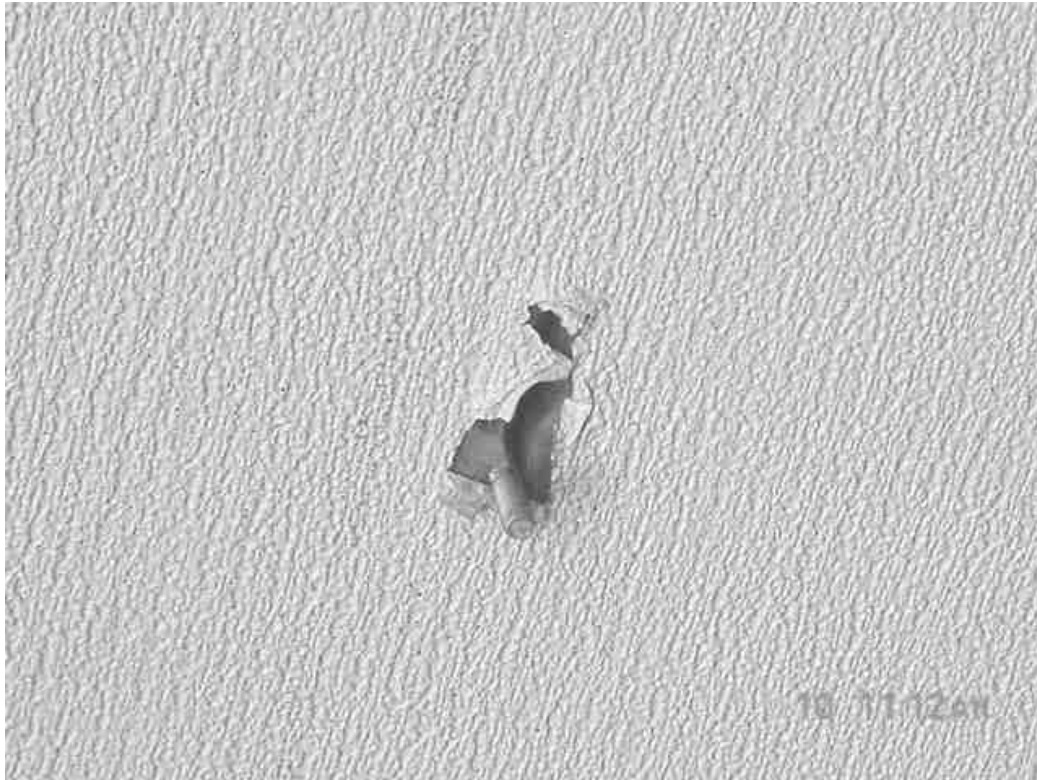
Finally, ceiling tiles are made of a fiberglass material. In many areas the tiles were damaged resulting in exposed fiberglass in classrooms (Pictures 17 and 18). As discussed in the temperature section of this report, fiberglass insulation was stuffed into a ceiling-mounted supply vent (Picture 6), which can aerosolize fiberglass fibers. Fiberglass insulation can be a source of skin, eye and respiratory irritation to sensitive individuals.

Damaged Ceiling Tile Exposing Fiberglass
